Manhole Inspection Summary

Manhole # S33QQ1007MH

Insp Date: **6/27/08 9:16 AM**

Location Address: **200 WINSTON AVE**

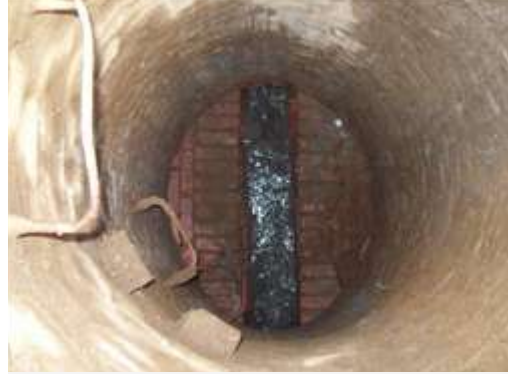
Top View

Steps Count: **4** Missing: **1** ☒ **Corroded**

Surcharge ☒ **Evidence Of Surcharge** Depth: **1.5** (ft.) ☐ Active Surcharge Present

Corroded and missing steps. Evidence of surcharge - Bench debris.

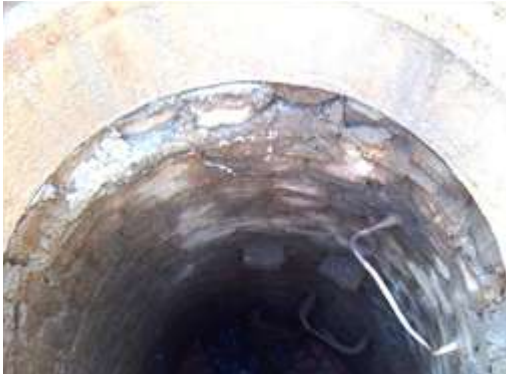
Defect

Frame Offset: **1** (in.) Condition: ☐ Sound ☐ Cracked ☒ **Leaks**

Condition: ☐ Sound ☐ Cracked ☐ Root Intrusion ☐ Loose Brick ☒ **Deteriorated**

Infiltration: ☐ None ☒ **Joint** ☐ Cracks ☐ Mortar ☐ Roots ☒ **Wall**

Infiltration: ☐ None ☐ Joint ☐ Cracks ☒ **Mortar** ☐ Roots ☒ **Wall**

Frame leaks. Adjustment deterioration and infiltration. Corbel and Barrel infiltration.

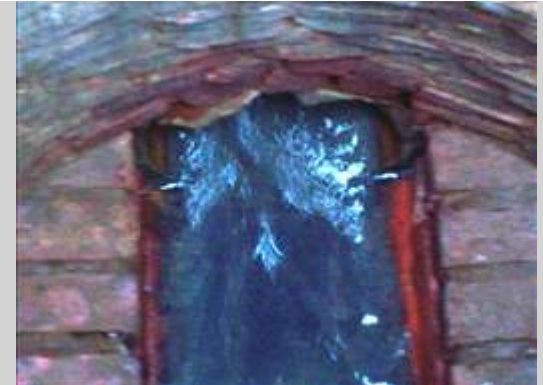
10 in. Circular Gravity Sewer Pipe Out @ 12 O'Clock

Condition: ☐ Sound ☐ Cracked ☐ Root Intrusion ☐ Loose Brick ☒ **Deteriorated**

Infiltration: ☐ None ☐ Joint ☐ Cracks ☒ **Mortar** ☐ Roots ☒ **Wall**

Barrel deterioration and infiltration.

Infiltration: **Evidence** Pipe Seal Cond: **Broken**

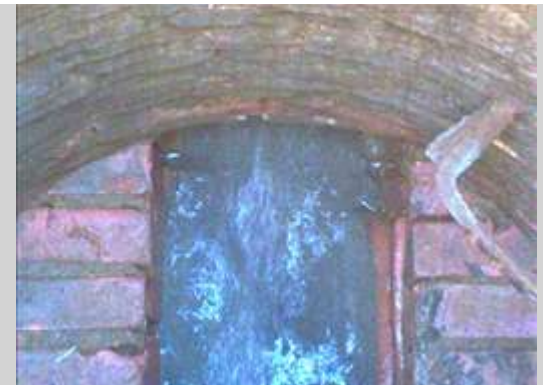
10 in. Circular Gravity Sewer Pipe In @ 6 O'Clock

Infiltration: **None** Pipe Seal Cond: **Cracked**
